A Case Study of a Pull Rod Failure in ATOX Raw Grinding Mill

Biju Karakkunnummal*

R&D Product Development, Flsmidth Private Limited, 34 Egatoor Kelambakkam, India

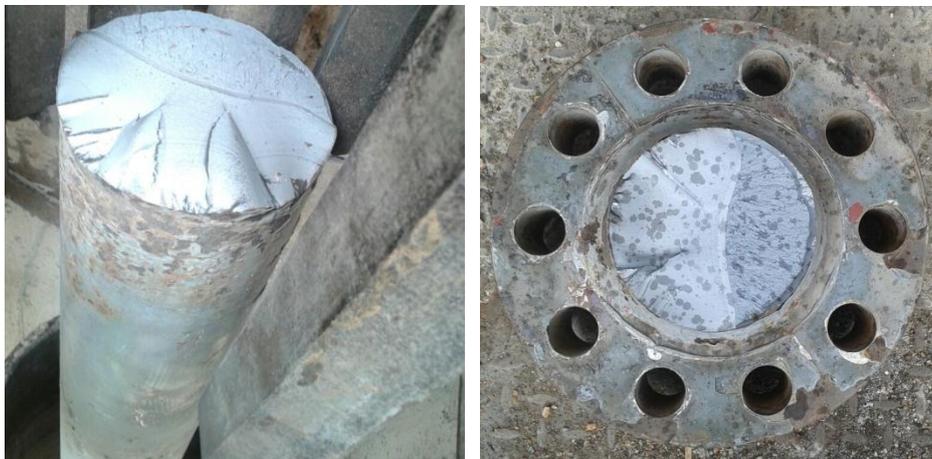
A failed pull rod was received from a cement plant for a detailed investigation and to identify its cause of failure as shown in Fig. 2. It was reported that the pull rod failed after 462 hours in operation. The failed pull rod was installed as a replacement for another pull rod, which failed after 8 years in operation. The failure history of the old pull rod was not known. It was reported that the replaced pull rod failed during operation. Customer brought two spare pull rods along with the three original pull rods, and these two

Fig. 2. Failed material received from customer site.

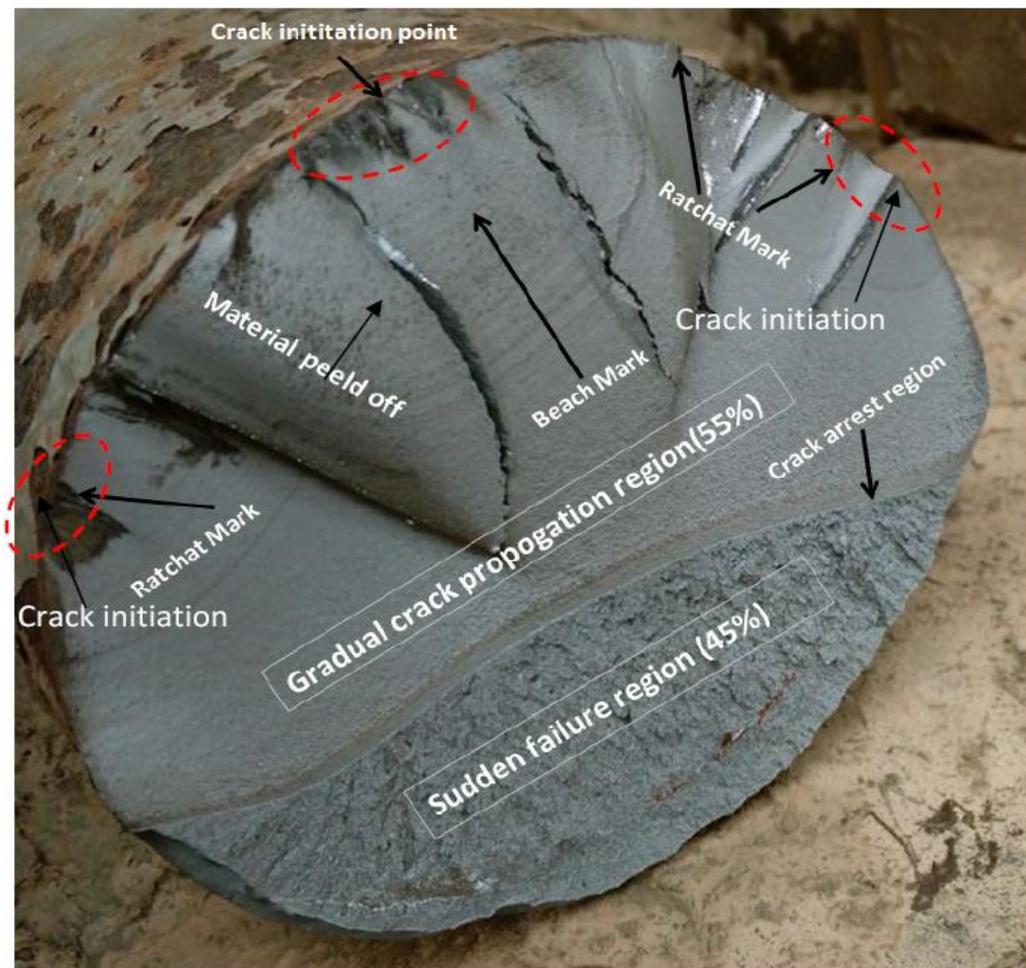
Visual examination was performed using low magnification lens. As received pull rod material was rusted heavily and no material identification mark was seen on the sample. Examination of the fracture surface is shown in Fig. 3, revealed characteristics such as beach mark associated with fatigue. Multiple cracks were visible on the fracture surface. At some location, material was peeled off from the fracture surface. Several ratchet marks were visible on the fracture surface, which indicates multiple crack initiation region. The fracture surface shows a clear indication of fatigue failure. The edges of crack resembles multi branching tree like appearance.

Fig. 3. Fracture surface of failed pull rod.

The fracture surface showed beach mark associated with fatigue. Several ratchet marks were also visible on the fracture surface, which is an indication of multiple crack initiation. Sharp corners on the fracture

surface also indicated the presence of stress concentration on the pull rod material. The surface area of final fracture was approximately 45% of the total fracture surface suggesting that the pull rod was overstressed. Small overload region and large fatigue region with multiple ratchet marks indicates that the load was light, but there were high stress concentration on the crack initiation region. It was informed that there was no related failure of bolt, nuts along with the pull rod failure. Any overloading or high bending stress would have caused the failure of bolts, which was connected with the pull rod. From this analysis, we conclude that the bad quality of the pull rod material caused the premature failure.

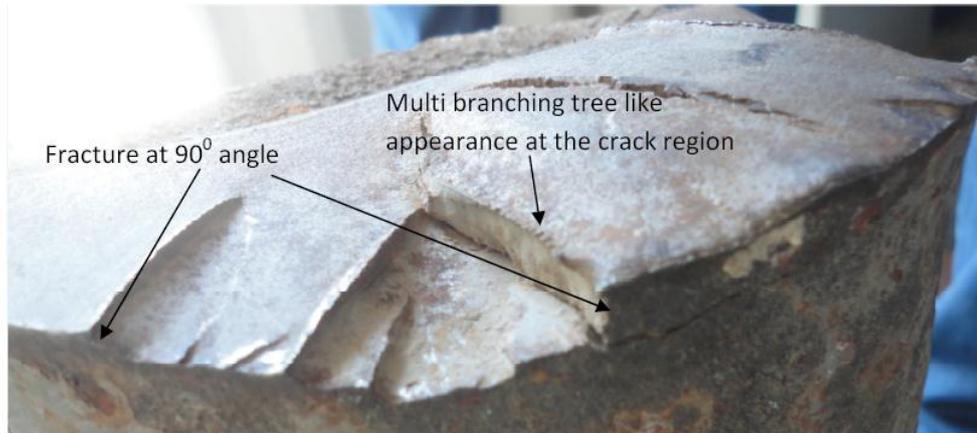
Fig. 4. Flaky appearance of material removal from the pull rod.

5. Morphology of fracture surface indicates the failure was due to one side-bending load from the crack initiation region.
6. The side of ratchet mark was perpendicular to the fracture surface (refer figure 4), which indicates that the plane bending or tension caused the failure.

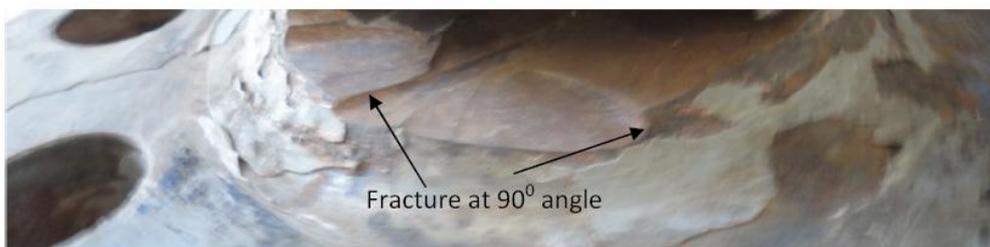
Fig. 5. Flaky appearance of material removal from the pull rod.

9. The material removal was in a flaky manner (refer figure 5). At some location, no cracks were present at the surface, but at the core region.
10. It was informed that no other related failure of bolt and nuts took place along with the pull rod.

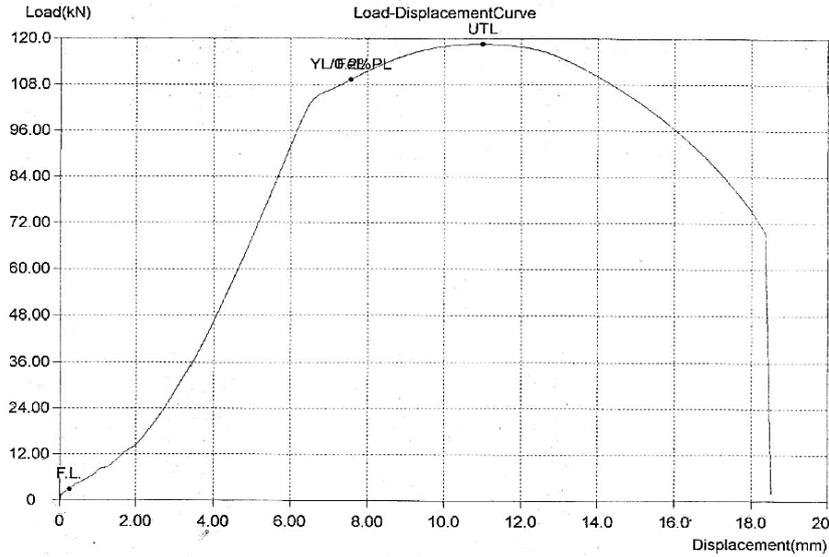
Fig. 7. Load versus elongation curve of failed tensile sample.

Tensile test was carried out at room temperature in longitudinal direction to understand the tensile property of the pull rod. The results are summarized in Table 3. The test results showed that tensile properties were slightly lower than the usual test results. The tensile strength was lower than the specified value and yield strength was only marginally above the specified value. The tensile specimen showed cup and cone fracture with sufficient necking, which shows the ductile behavior of material. The ductility of the material was good, but the fatigue property of the material would have reduced due to the poor tensile strength. The reduction in tensile property of material could be due the presence of non-homogeneous structure, which is presented in the subsequent discussion.

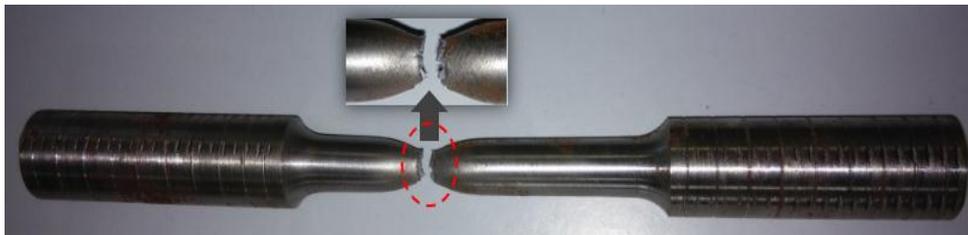
Fig. 8. Fracture surface of tensile specimen

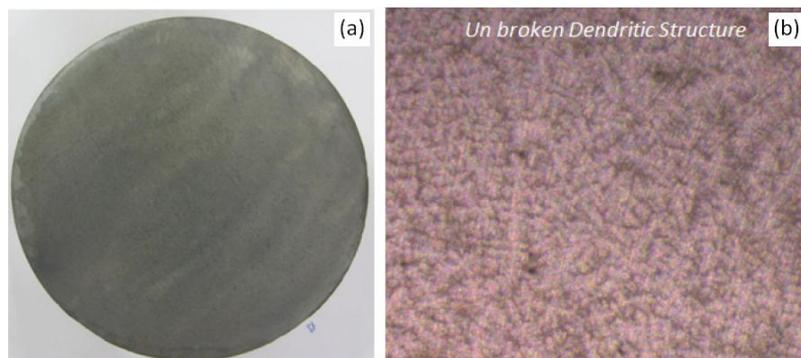
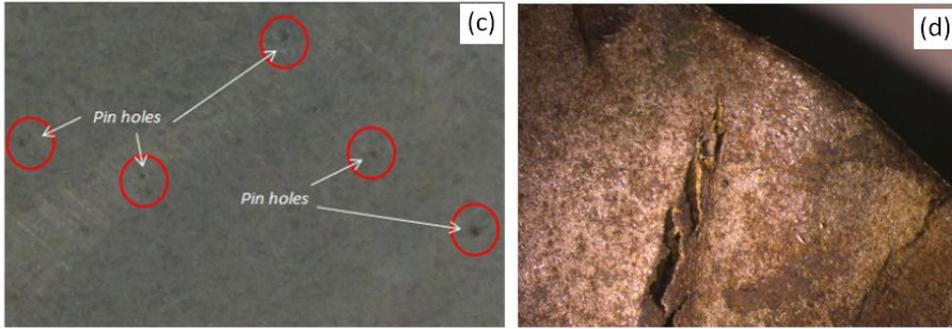
Fig. 9. Macro etched sample (a-c); Stereographic macro examination (d)

Macro examination was carried out using 1:1 hot solution of hydrochloric acid and water for 30 minutes. Severe blowholes and pinholes were noticed in the macro-etched specimen. There was an unbroken coarse dendritic structure visible, which is not acceptable for a forged product. We also noticed a segregation pattern at certain regions of macro-etched specimen. The macro-etched specimen revealed a non-homogenized structure.

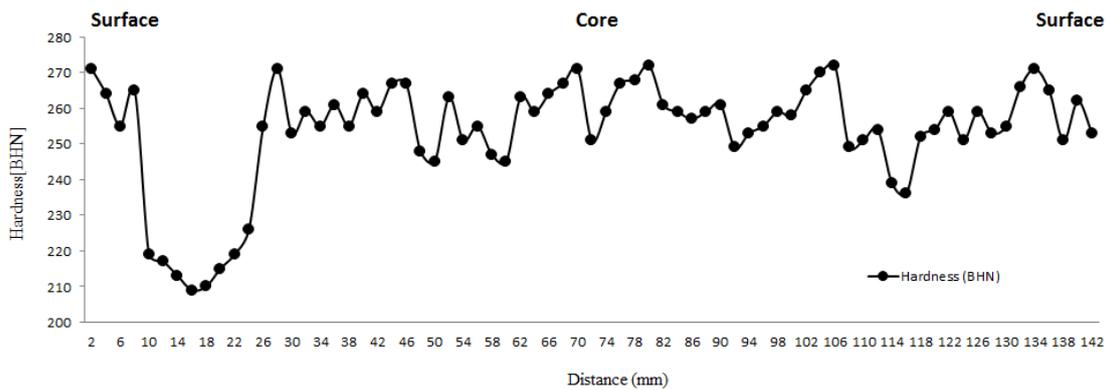
Hardness mapping was carried out from surface to core (around 72 points) as per ASTM E 10-2010. The test results are shown in Fig. 10. Variations in hardness were observed from surface to core as shown in Fig. 10.

Fig. 10. Hardness mapping (surface to core) in the shaft

Vicker hardness mapping was carried out at an interval of 2 mm on the cut section of pull rod from surface to core. The results are summarized in figure 10. A large variation of hardness was observed at several locations. The variation in hardness would be due to the segregated pattern in the unbroken dendritic structure and the presence of non-homogenize microstructure structure and other anomalies such as blowholes, inclusion etc.

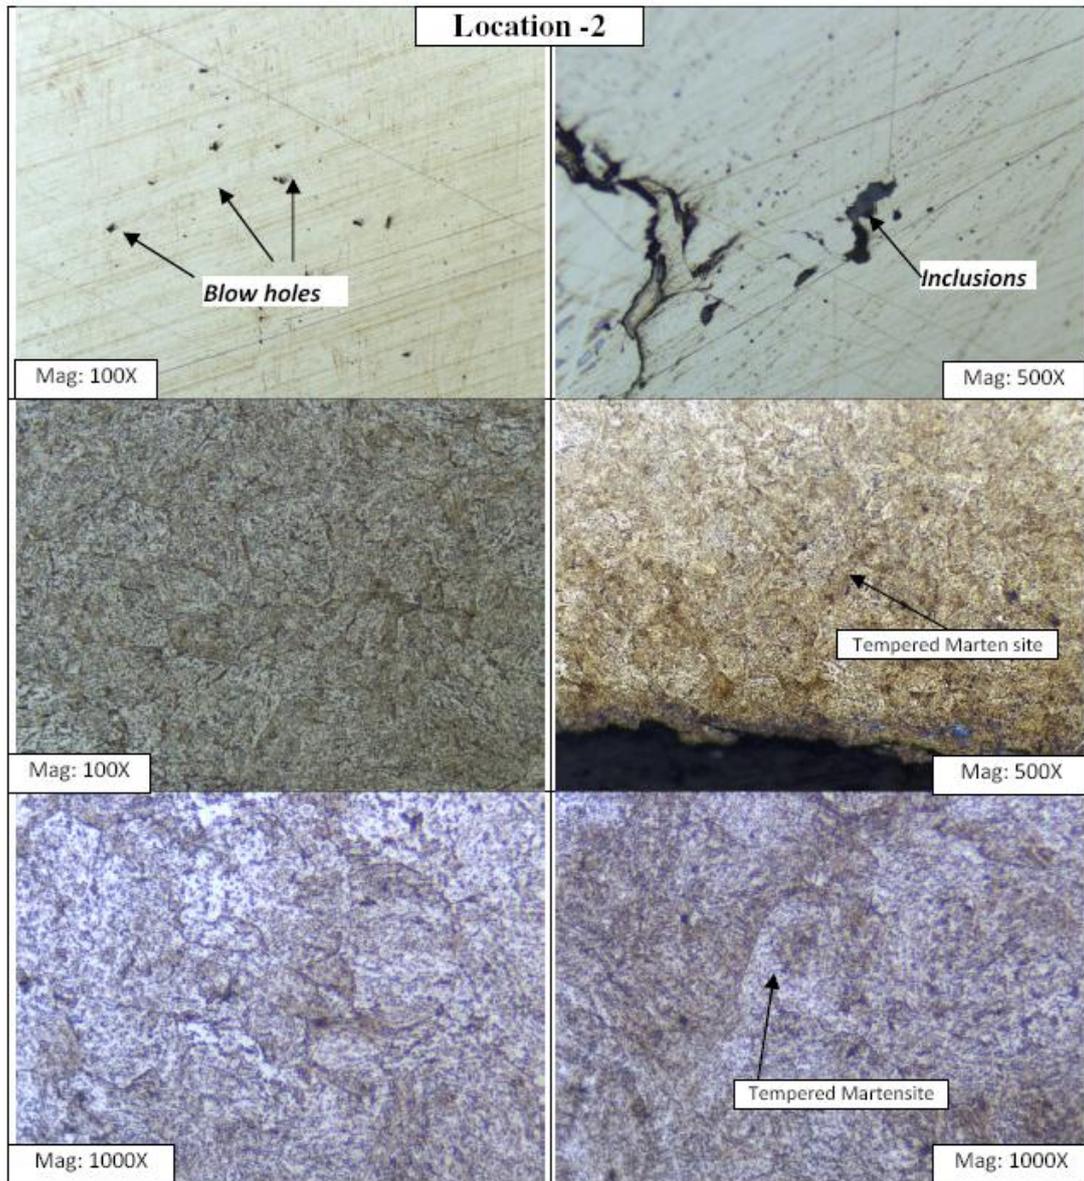
Microstructural examination was carried out as per ASTM E23-2007 at various locations (Fig. 11-12 a – b). Samples were polished and etched with Nital reagent to reveal the microstructure. Etched sample revealed non-homogeneous tempered martensite matrix structure at different locations. The grain size was not uniform and several blowholes and non-metallic inclusions were noticed during microscopic examination.

Figure 11. Micro examination at location 2.

Microstructure analysis was carried out at different locations on the failed sample. The microstructure predominantly tempered martensite. However, variations in grain size were noticed at different locations. Microstructural examination at the edges of crack initiation points revealed the presence of a large quantity of exogenous type inclusions.

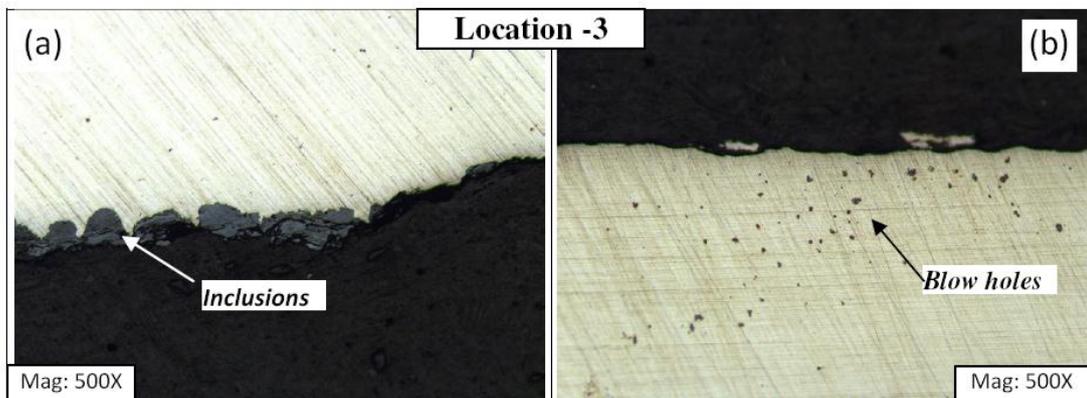
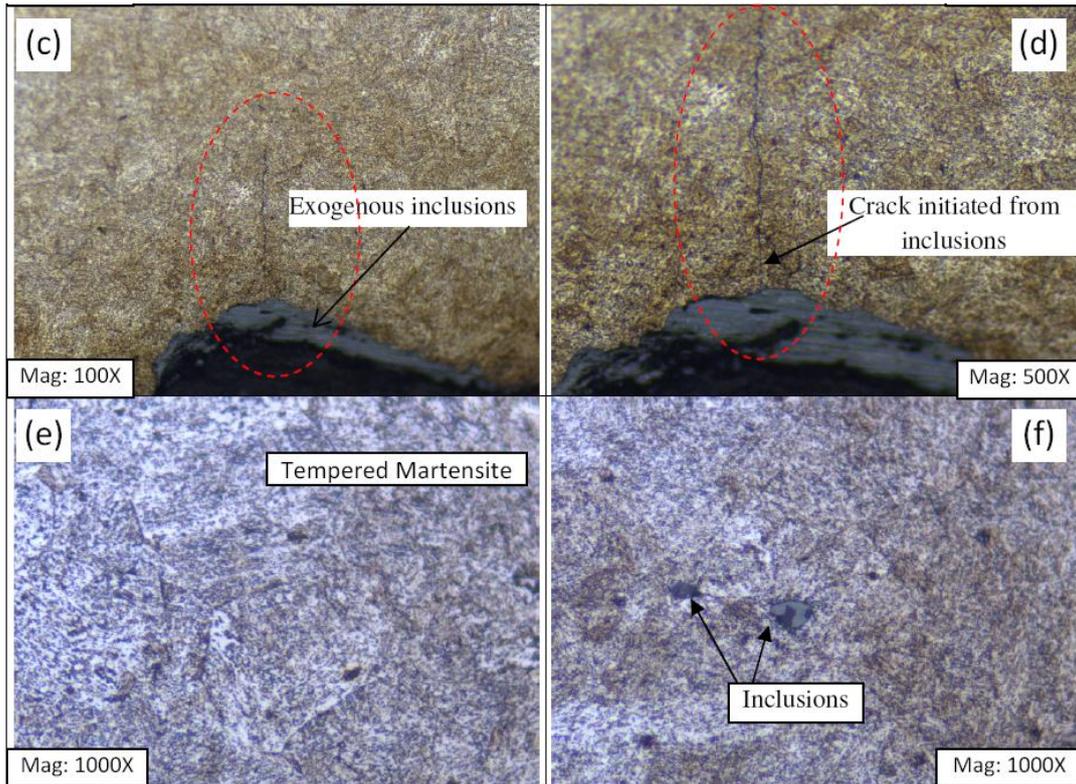
Figure 12(a). Micro examination at location 3.

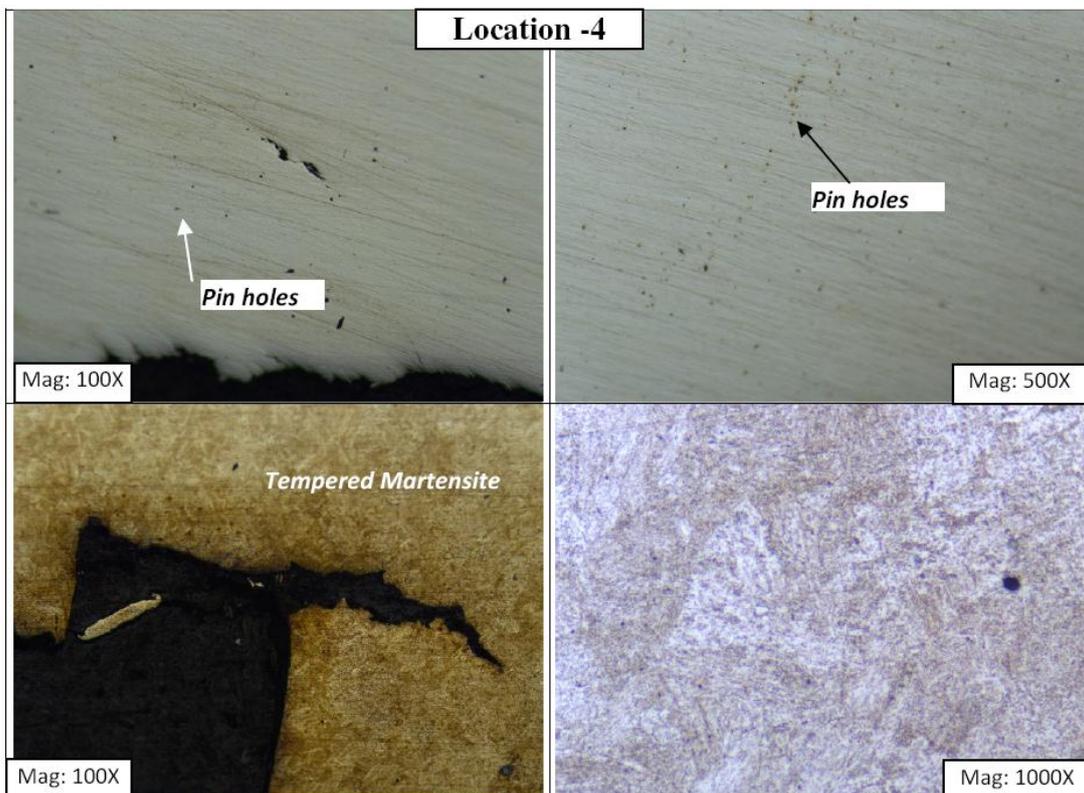
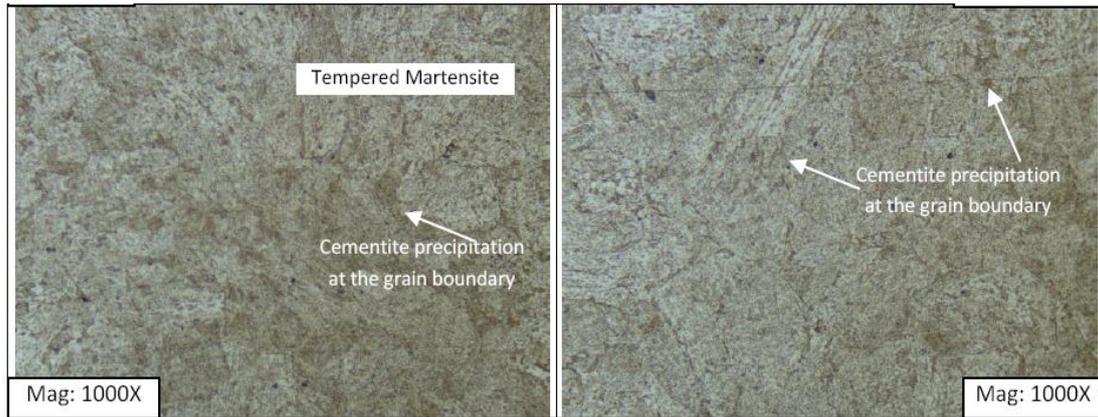
Micrograph taken at one of the crack-initiated region shows the heavy presence of non-metallic inclusions. The cracks were initiating from these inclusions as shown in Fig. 12 c and d.

Fig. 12(b). Micro examination at location 4.

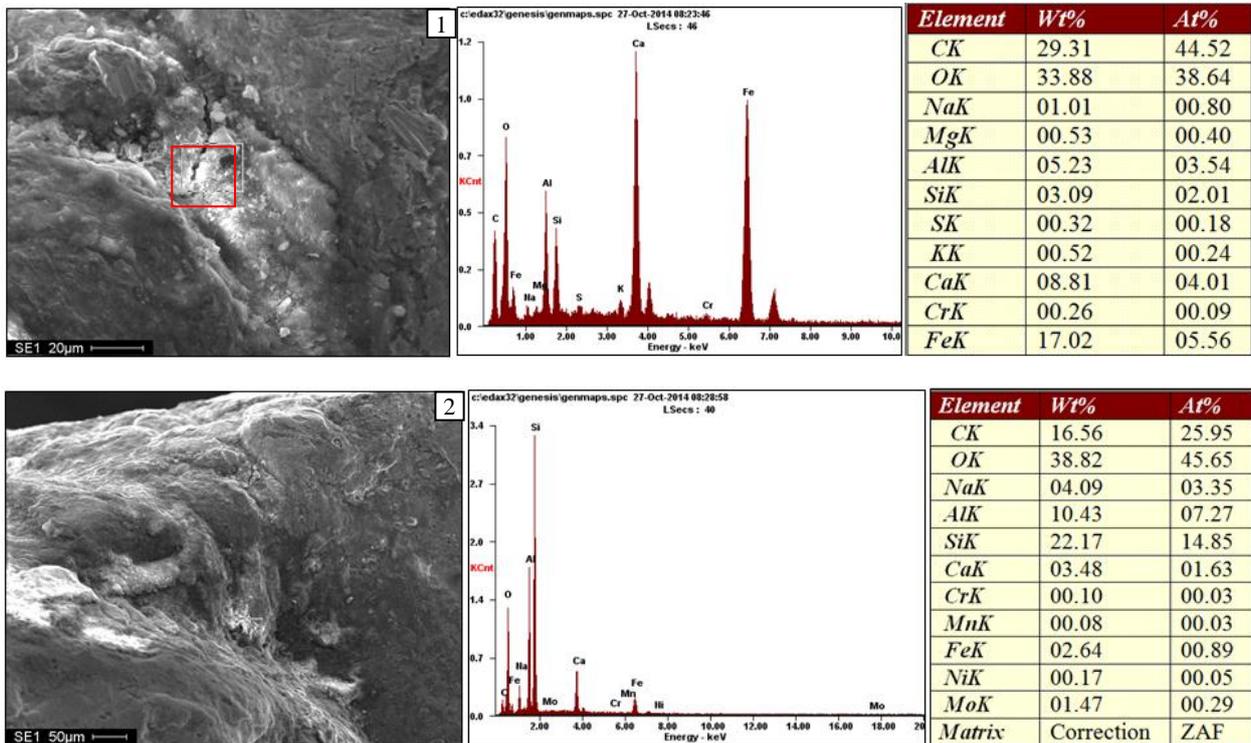
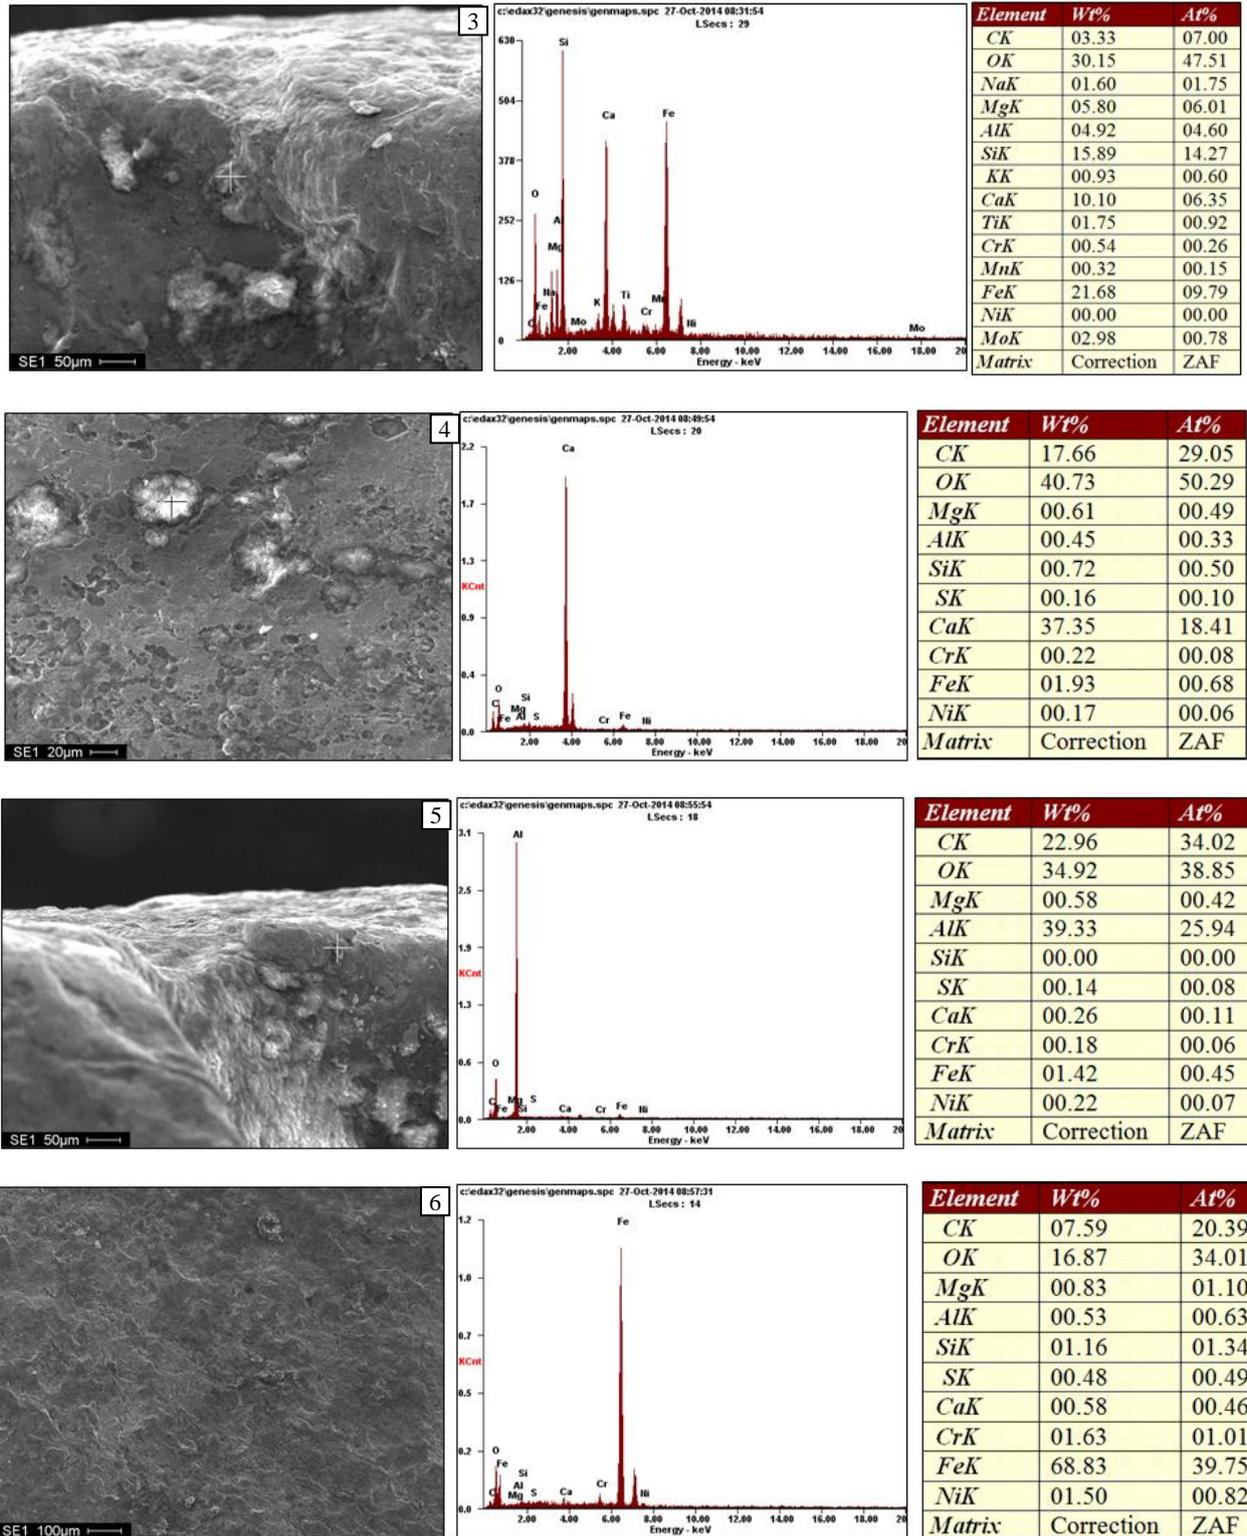
The fracture surface of the pull rod was cut at various locations to study the Fractography. The fracture surface was cleaned with acetone in order to remove the foreign deposits. The scanning electron micrograph is shown in Fig. 13-6, clearly indicates that the fracture surface is smooth and crack propagated by transgranular mode [7]. There is no detachment of grain observed in the micrograph. The crack propagated across the grain boundary and failed by fatigue mode. However at the crack initiation point the presence of exogenous inclusion was noticed with the help energy dispersive X-ray analysis.

Scanning electron micrograph taken at various locations shows predominantly the presence of exogenous type of inclusions which would be the cause of failure of pull rod.

Fig. 13. SEM-EDX analysis at the crack region

The relative quantities of elements were determined by EDX analysis and results are summarized in Fig. 13. SEM-EDX analysis at the edges of crack revealed the presence of oxides of Alumina, Calcium and Silicate. These exogenous inclusions [8] lead to increase in stress concentration and cracks had initiated from this point and propagated through the unbroken inter dendritic region. The crack initiation depends on the severity of inclusion present in the structure (Fig. 14).

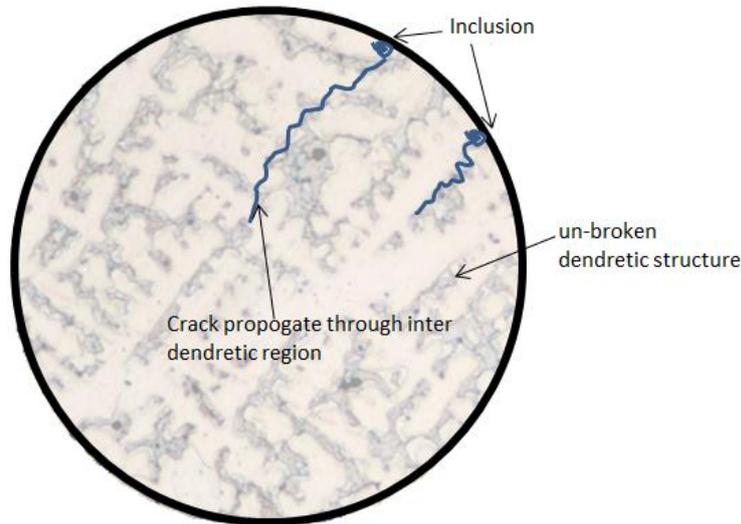
Fig. 14. Crack initiation and propagation

5. The crack was caused by low cycle fatigue, which was initiated due to the presence of exogenous type inclusions in the pull rod. The de-cohesion of inclusions leads to micro cracks on the surface and propagated along the inter dendritic region by fatigue mode.
