Case Study on Failure of Ti Lining

2. Case History

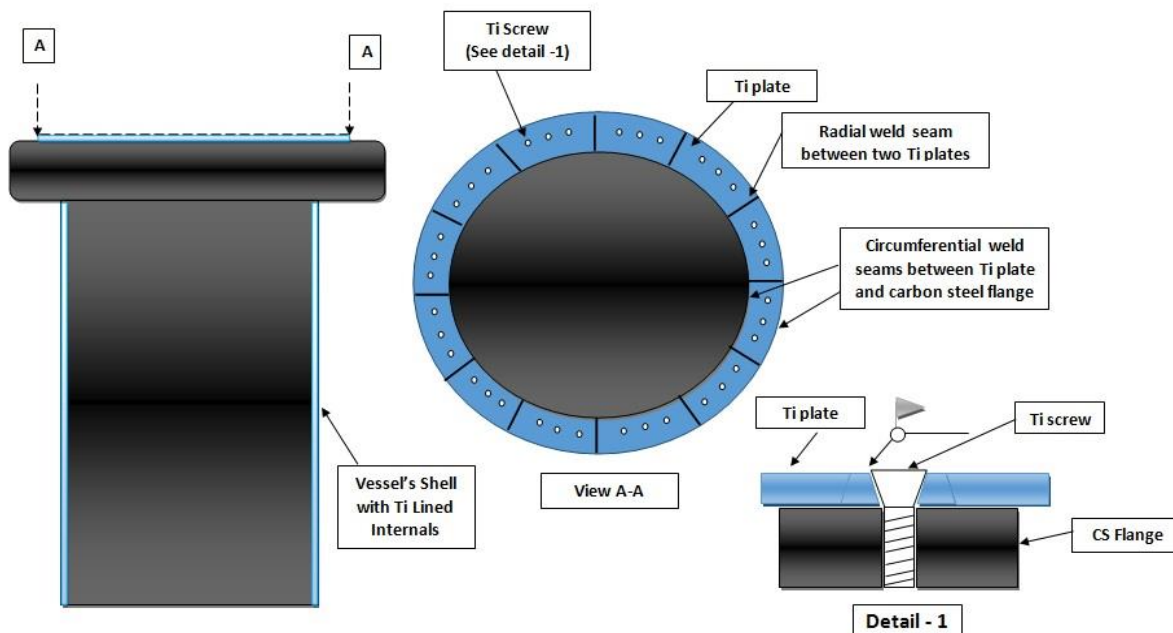
Fig. 1. Proposed arrangement for Ti lining and bolts on flange's face.

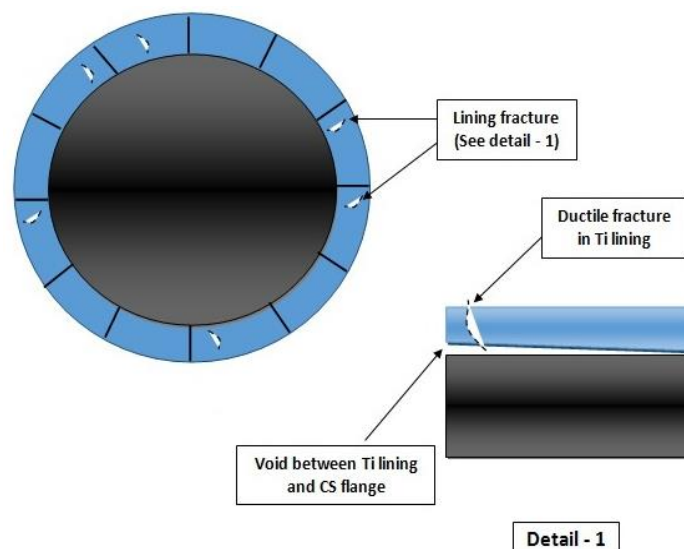
Post-failure visual analyses revealed that Ti lining had bulged and fractured at multiple locations around the circumference of flange's face. Also, ultrasonic examination revealed thinning of Ti lining with resulting thickness up to 0.5 mm (instead of ~ 3.0 mm) in the vicinity of fractured Ti lining. Damaged Ti lining was peeled at thinned locations (using grinding) in order to inspect the cross-section of interface between lining and flange's face. Considerable voids between thinned Ti lining and underlying CS flange were observed; and were indicative of lining delamination due to bulging. Here, thinning of certain segments of Ti (relative to others) can be attributed to non-homogenous gap between Ti lining and CS flange, as lining wasn't perfectly sitting (rather distorted) on the underlying CS flange. Ti lining was bulged even before the in-situ machining due to higher heat intake from continuous welding and absence of any distortion control strategy. It is worth noting that lining distortion due to welding heat is a dislocation movement mechanism; that follows the pattern of caterpillar movement from hot end of plate to the colder end [1].

The same gap i.e. between Ti lining and underlying CS flange led to un-even surface of Ti lining, thereby leading to non-homogenous material removal during in-situ machining. Moreover, the absence of leveling checks (by dial indicators) before in-situ machining (and after welding) resulted in unrevealed and bulged (rather even) face of Ti lining. Due to this un-rectified bulging of Ti lining's surface, in situ machining caused more removal of material from the portions that were bulged compared to the rest of/ un-distorted lining. Fracture failure happened at the same portions that were subjected to thinning from bulging and subsequent machining as shown in Fig. 2. The fractured edges of Ti lining showed some localized elongation, that's an evidence of ductile fracture under the load of top cover at the portions with reduced thickness.

Fig. 2. Damaged lining on flange's face due to thinning and voids.

Here, consideration of dislocation motion and consolidating the bolts tightening sequence with weld heat control, and movement of welding torch could have minimized the lining distortion. Repair strategies should take into consideration relative coefficients of thermal expansion of dissimilar metals as it is critical to the formation of voids between lining and underlying material. An example would be the use of SS (stainless-steel) lining on carbon steel's surface, where higher relative thermal expansion coefficients (of CS & SS) may cause the formation of voids. The possible alternative solutions in such scenarios could be welding build up using SS electrodes or use of factory-applied SS claddings on CS. Another known practice is to limit the use of

Consideration of metallurgical mechanisms (such as dislocation movement due to weld's heat) can be vital in developing the applicable welding and distortion control procedures. Dial indicator test after welding of lining (and before machining) is highly crucial and can reveal distortions and can aid in pro-active addressing of any thinning from in-situ machining. Thickness and material of cladding/lining plates should be as to compensate for machining allowance as well as to withstand compressive loads in ductile fashion in the event of any gaps/ distortions. Always conduct point contact test (e.g. blue match paste test) between lining and underlying material before fit-up in order to reveal any mismatch among the mating surfaces. Furthermore, a well-established mockup strategy for repair of aged and dissimilar materials can reveal bottlenecks and constraints that are likely to occur during actual repair works. Finally, the repair strategy for any damaged lining should take into consideration various factor such as galvanic numbers of dissimilar materials, sensitivity of surface's flatness towards leak tight application, geometry, level of ductility for lining, relative coefficients of thermal expansions for lining and underlying metal as well as condition of underlying metal etc.
