# The Role of Surface Texture on the Corrosion Fatigue Behavior of High Alloyed Stainless Steel Exposed to Saline Aquifer Water Environment

**Abstract:** Corrosion fatigue specimen with different surfaces (technical surfaces after machining and polished surfaces) of high alloyed martensitic stainless steel X46Cr13 (1.4043) and duplex stainless steel X2CrNiMoN22-3-2 (1.4462) were compared at load amplitudes from 175 MPa to 325 MPa in the geothermal brine of the Northern German Basin at 98 °C. Surface corrosion layers and pits reveal carbonate corrosion products on the surface such as FeCO<sub>3</sub> and FeOOH as the main precipitation phases with no dependence on the original surface roughness. At high stress amplitudes above 275 MPa technical surfaces (P50% at  $\sigma_a$  300 MPa=5×10<sup>5</sup>) resulted in more cycles to failure than polished (P50% at  $\sigma_a$  300 MPa=1.5×10<sup>5</sup>). The greater slope coefficient for technical surfaces k = 19.006 compared to polished surfaces k=8.78 demonstrates earlier failure at given stress amplitude  $\sigma_a$ .

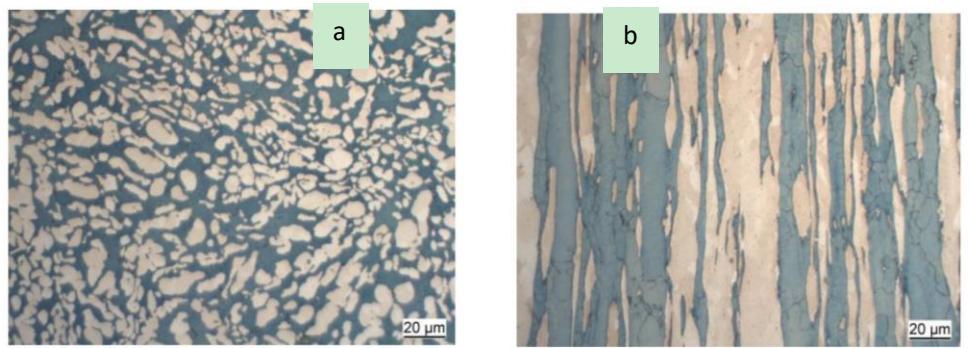
Fig. 1. Microstructure of 1.4462 test specimens prior to exposure; left: 1.4542 after heat treatment, middle (a) transversal and right (b) longitudinal sections respecting the casting direction [8]. Etching: Beraha II.

strength 864 MPa in air. The high strength of 1.4462 results from fabrication process, microstructure and additional alloying elements, in particular nitrogen and [22]. Fig. 1 depicts the alloy's microstructure obtained via etching prior to exposure and fatigue testing.

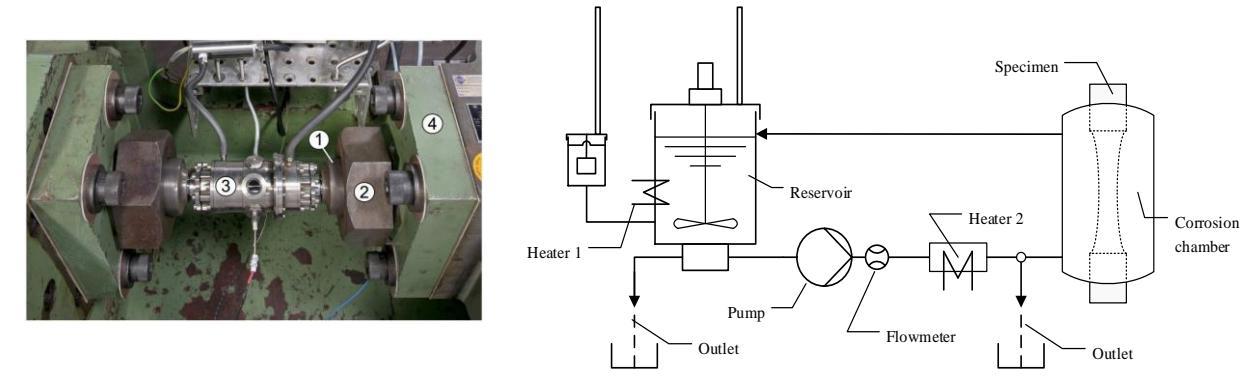
Fig. 2. Schematic set-up of operating corrosion chamber for in-situ corrosion fatigue testing [8], [24]. (clamping socket (1), union nut (2), corrosion chamber (3), clamping plate (4)).

The shape and dimensions of hourglass specimens (Fig. 2) were selected in accordance to the standard DIN EN ISO 11782-1 and to the recommendations of the FKM Research Issue [23]. The critical cross-section is 12.5 mm in diameter; the total contact surface area did not undergo 25 cm<sup>2</sup> in order to minimize the influence of irregularities [24].

The corrosion chamber is fixed directly onto the specimen leaving the resonant testing machine unaffected (Fig. 2) [8], [24]. It is equipped with measurement technique to obtain electrochemical data, temperature, the pH and the electrochemical potential during the mechanical tests using a special shock resistant silver-silver chloride electrode.

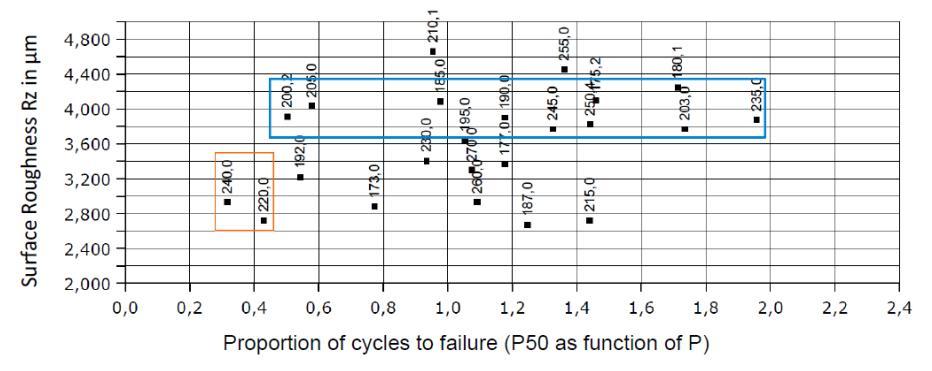
Fig. 3. Comparison of differently machined surfaces of 1.4043 (X46Cr13) in corrosive media [1] at 60 °C after machine turning (technical surface).

The influence of surface roughness of the fatigue behavior is demonstrated in Fig. 3. Here the surface roughness of specimens of 1.4043 (X46Cr13) is shown as a function of the proportion of cycles to failure (P50 to P).

The higher the number on the x-axis the higher is the 50% probability of survival at a given stress amplitude. The numbers in the graph exhibit the stress amplitudes in N/mm<sup>2</sup>. Surface roughness of as-machined specimens varied between 3.6 and 4.7  $\mu$ m. As the main result there is no significant

dependence of the surface roughness after fine machining on the fatigue behavior. Although there are 2 specimens with very high P50 cycles to failure (orange square) there are as many specimens with similar surface roughness revealing higher or lower numbers of cycles to failure (blue square).

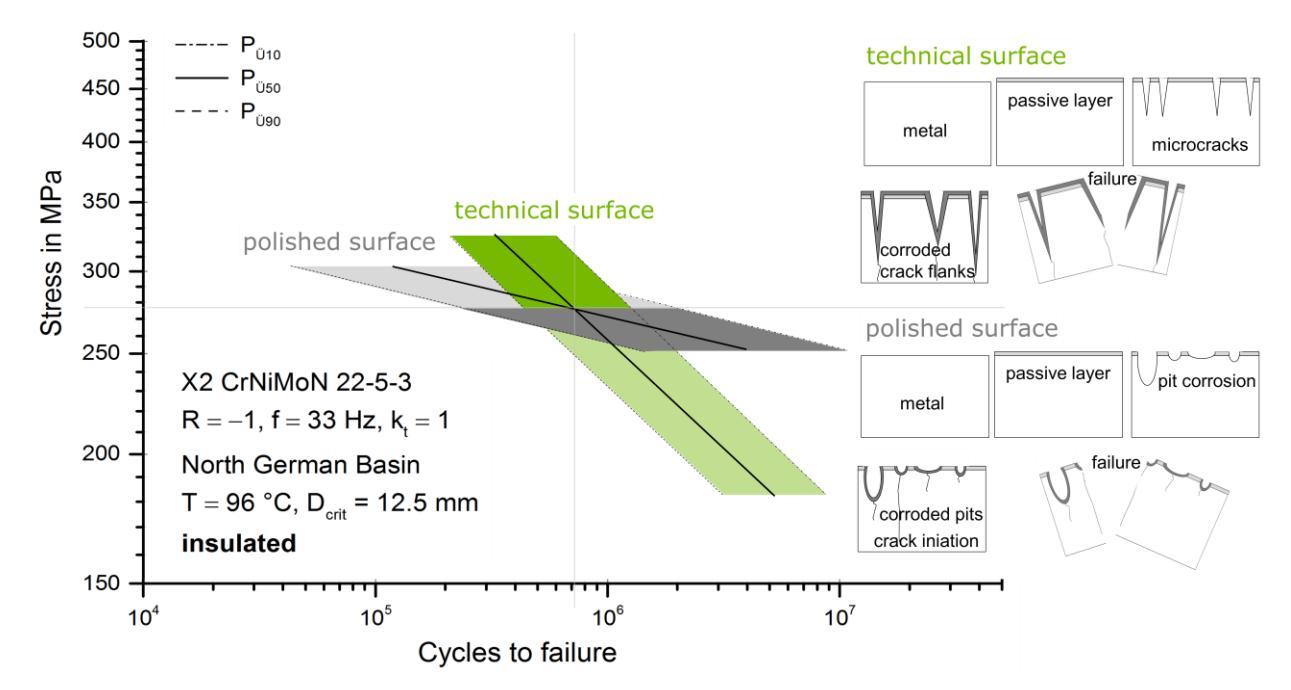
Fig. 4. S-N curve of 1.4462 X2CrNiMoN22-5-3 in air and in corrosive media Northern German Basin at 98 °C after machine turning (technical surface) and polishing (polished surface).

In general the endurance limit for specimen of duplex stainless steel 1.4462 (X2CrNiMoN22-5-3) cycled in air is higher by a factor of 2.5 (485 MPa with regard to a fatigue limit of 10<sup>7</sup> cycles ( $P_f$  = 50%, purely alternating push/pull load) compared to specimen cycled in saline aquifer water. The line of regression of specimens with technical surfaces has greater negative slope (steeper) (k=8.78) than that of specimen with polished surfaces (k=19.006). Comparing slope coefficients k reveals that lines of regression with small number of k decline greater than those with large numbers of k (Fig. 4).

However, in the corrosive environment of the Northern German Basin specimen with technical surfaces (average surface roughness  $3.2\mu$ m) perform better at stress amplitudes higher than 270 MPa than polished (average surface roughness  $1.59 \mu$ m). At stress amplitudes S<sub>a</sub> below 270 MPa polished surfaces reveal much higher numbers of cycles to failure (Fig. 4).

At 275 MPa the regression lines overlap indicating that at 275 MPa stress amplitude the surface condition has little to no influence on the corrosion fatigue behavior. Below 275 MPa the crack growth is not initiated by micro cracks but via pit corrosion. Initial pits first grow in dimension and after reaching a critical size and are then followed by the formation of a fatigue crack (Fig. 5) due to a notch effect [8] resulting in early failure. Therefore it is very likely that corrosion prior to micro cracking is primarily cause for fatigue failure under given experimental conditions. Because here pitting is reason for crack initiation and not micro cracks, a polished surface is preferable because it provides better resistance to corrosive attack and higher numbers of cycles to failure.

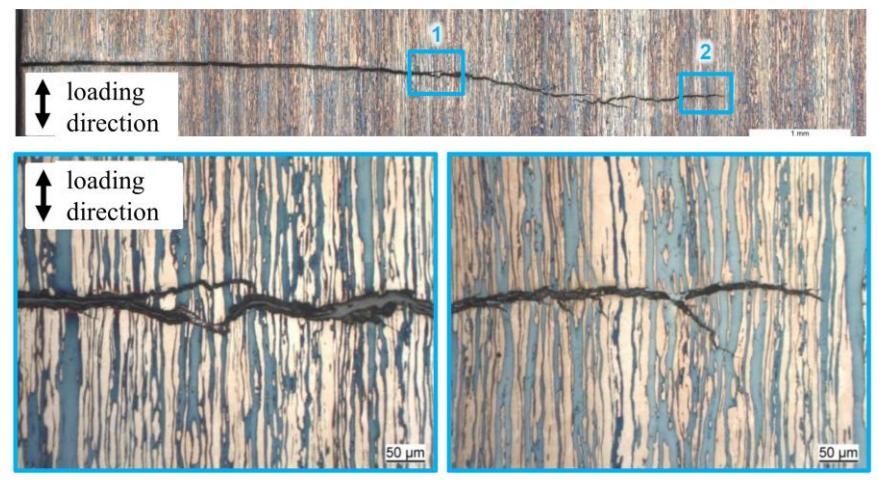
Fig. 5. Micro sections of major crack initiation (left) and major crack termination zone(right). 1D13X (380 MPa; 0.36·10<sup>6</sup> cycles).

Furthermore, the supercritical crack growth mechanism may change after exceeding stress amplitudes above 275 MPa. At stress amplitudes greater 275 MPa the push-pull load will lead to overall tensile stress in the specimen surface resulting in micro cracks (Fig. 5). Further cycles alternately open and close the crack exposing the crack flanks to the highly corrosive brine. Due to a low solubility limit in aqueous solutions (pKsp = 10.54 at 25  $\circ$  C [21], [25] siderite will form as a result from the transient phase precipitation of Fe(OH)<sub>2</sub> [25] and segregate. Further mechanical stress and the strain mismatch of corrosion layer and base
